TEST REPORT

No. : XMIN2003000821CM-01

Sample Name : WATER RESISTANT LAMINATE

Product Specification : 8mm

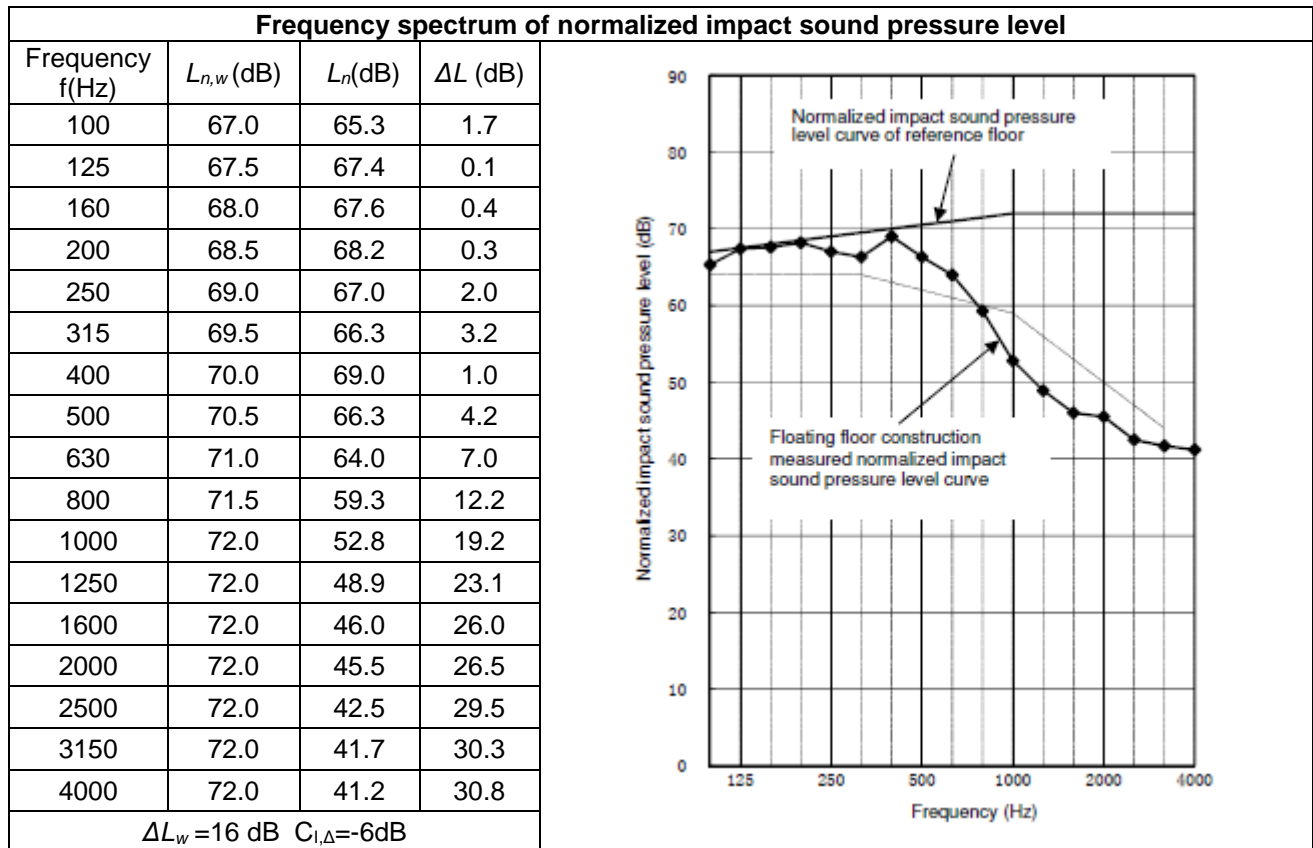
- Sample Description : Flooring (see the photo)
Total Thickness:8mm, surface density: about 7.9 kg/m²
- Test conducted : ISO 10140-1:2016, ISO 717-2:2013
- Project description : No decoration of sample surface and installation assembled directly.
The test specimen was covered on a 150mm concrete floor, testing area 11.3m²
- Test Equipment : RTA840 system
- Test Environment : Source room volume 125m³, receiving room volume 100m³,
air temperature 18.3 °C, air humidity 38.6%

No.	Test Item	Test Method	Result
1	Improvement of impact sound insulation	ISO 10140-1:2016 ISO 717-2:2013	$\Delta L_w = 16$ dB

1. $L_{n,w}$ as the weighted normalized impact sound pressure level
2. L_n as the measured normalized impact sound pressure level
3. The above test was carried out by Center for Building Environment Test, Tsinghua University.
4. This report supersedes the Report No. XMIN2003000821CM dated:Apr 08, 2020 issued by SGS, original report will be invalid from today.
