ATTAR TEST REPORT NUMBER: 14/8106.23

WET PENDULUM SLIP RESISTANCE

Prepared for:	Tarkett Australia Pty Ltd						
	16 Anella Avenue						
	CASTLE HILL NSW 2154						
Attention:	Maria Barreto-Tilman						
Test Site:	Test Slip Australia Pty Ltd, Beaumont Hills, NSW.						
Test Date:	12 August 2014						
Test Specimens, Size &	Granit Multisafe sheet vinyl, 300mm x 300mm,						
Quantity:	5 off.						
Sampling & Direction of Testing:	Sampling conducted by client. Testing carried out at						
	45° to profiled pattern. Refer to Figure 1.						
Test Personnel:	Clark Ahearn						
Preparation:	Washed with water and pH neutral detergent, rinsed						
	with water, then dried.						
Fixed/Unfixed:	Fixed.						
Air Temperature:	20°C						
Test Equipment:	Wessex Skid Resistance Tester (Pendulum) Serial						
	Number SK 1818, Calibrated 29/07/2014.						
Test Standard:	AS 4586: 2013 Slip resistance classification of new						
	pedestrian surface materials – Appendix A.						
Slider Rubber:	Slider 96 Batch No. #53 prepared on P400 & 3µm

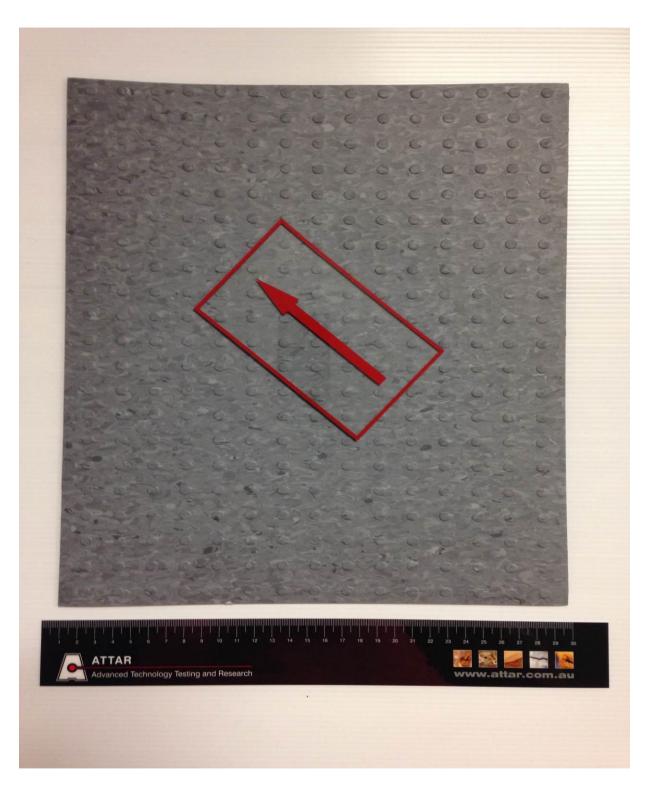
Figure 1: Granit Multisafe – Highlighted area indicates area tested and direction of test.

lapping film.						
Classification Criteria:	Refer to Classification Criteria, attached as Appendix 1.						
	Specimen Number					ODV	
British Pendulum Number	1	2	3	4	5	SRV	
	42	44	42	44	44	43	
Classification:	P3
