# KARNDEAN DESIGNFLOORING ACOUSTICAL PERFORMANCE TEST REPORT

ISO 10140-2, ISO 10140-3 TESTING ON  
4.5 MM LOOSELAY LLP109

Concrete Slab - 152 mm (6")

P1663.03-113-11-R0

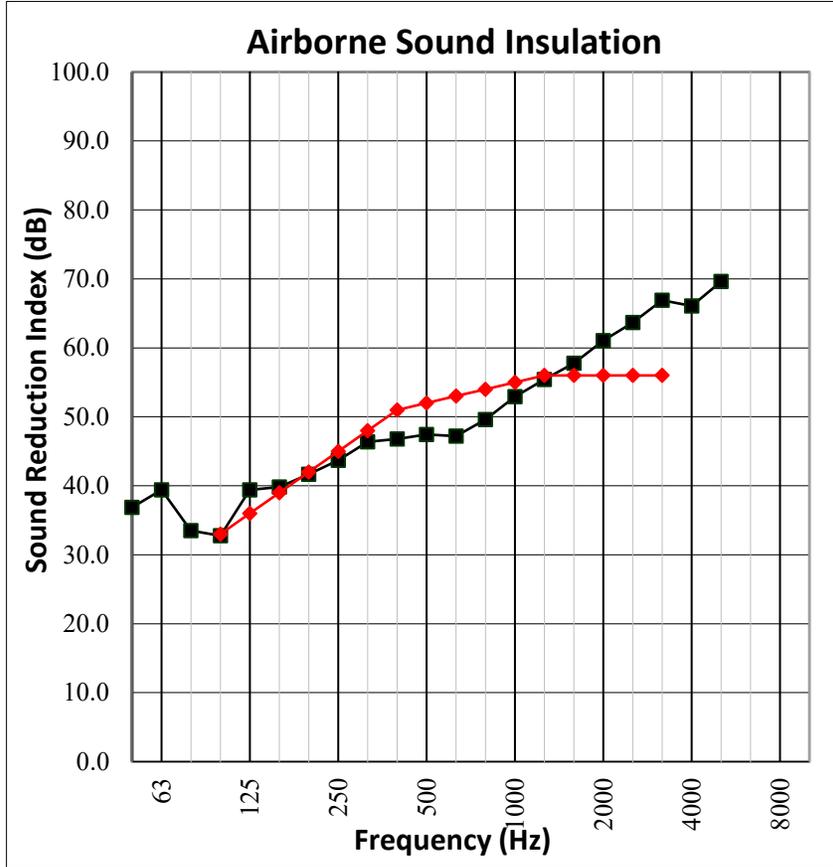
### SECTION 10

#### TEST RESULTS - SOUND REDUCTION INDEX (IN ACCORDANCE WITH ISO 10140-2)

FREQUENCY <i>f</i> Hz	<i>R</i> one-third octave dB
50	36.9
63	39.4
80	33.5
100	32.8
125	39.4
160	39.8
200	41.7
250	43.7
315	46.4
400	46.8
500	47.4
630	47.2
800	49.6
1000	52.9
1250	55.4
1600	57.8
2000	61.0
2500	63.7
3150	66.9
4000	66.1
5000	69.6

Rating in accordance with ISO 717-1:			
$R_w(C; C_{tr}) = 52$ dB	$C_{50-3,150} = -1$ dB	$C_{50-5,000} = 0$ dB	$C_{100-5,000} = 0$ dB
Evaluation based on laboratory measurement results obtained by an engineering method:			
$C_{tr,50-3,150} = -6$ dB	$C_{tr,50-5,000} = -6$ dB	$C_{tr,100-5,000} = -5$ dB

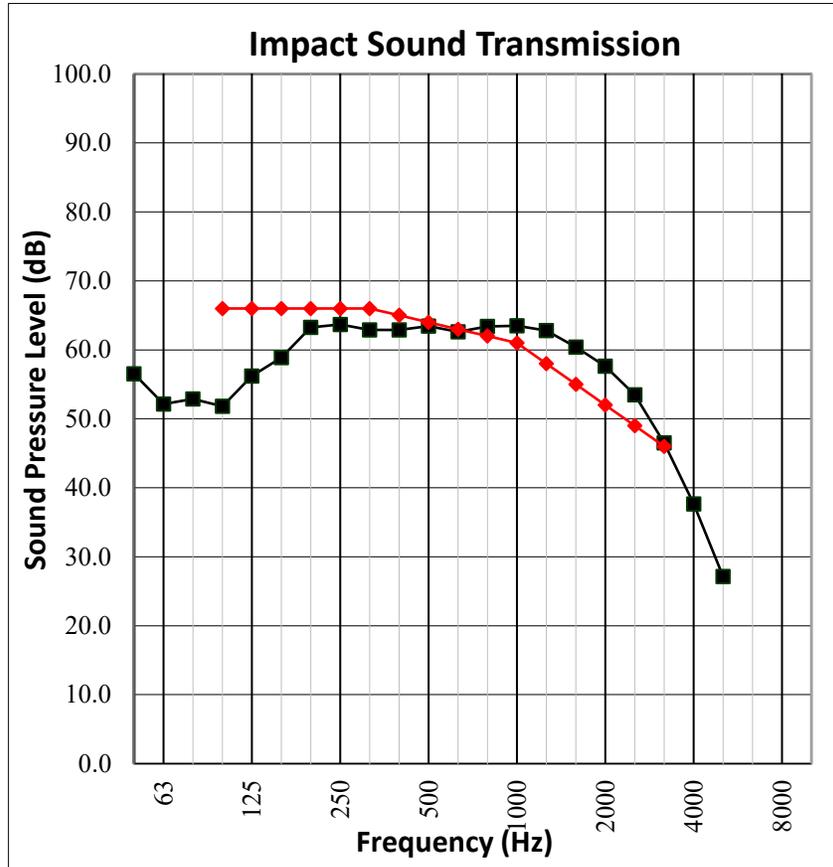
### SECTION 11

#### TEST RESULTS - NORMALIZED IMPACT SPL (IN ACCORDANCE WITH ISO 10140-3)

FREQUENCY <i>f</i> Hz	<i>L<sub>n</sub></i> one-third octave dB
50	56.5
63	52.1
80	52.9
100	51.8
125	56.2
160	58.9
200	63.3
250	63.7
315	62.9
400	62.9
500	63.5
630	62.6
800	63.4
1000	63.5
1250	62.8
1600	60.4
2000	57.6
2500	53.5
3150	46.5
4000	37.7
5000	27.1

$$L_{n,w}(C_1) = 64 \text{ ( -6 ) dB} \quad C_{1,50-2,500} = -5 \text{ dB}$$

$$\Delta L_w = 14 \text{ dB}$$

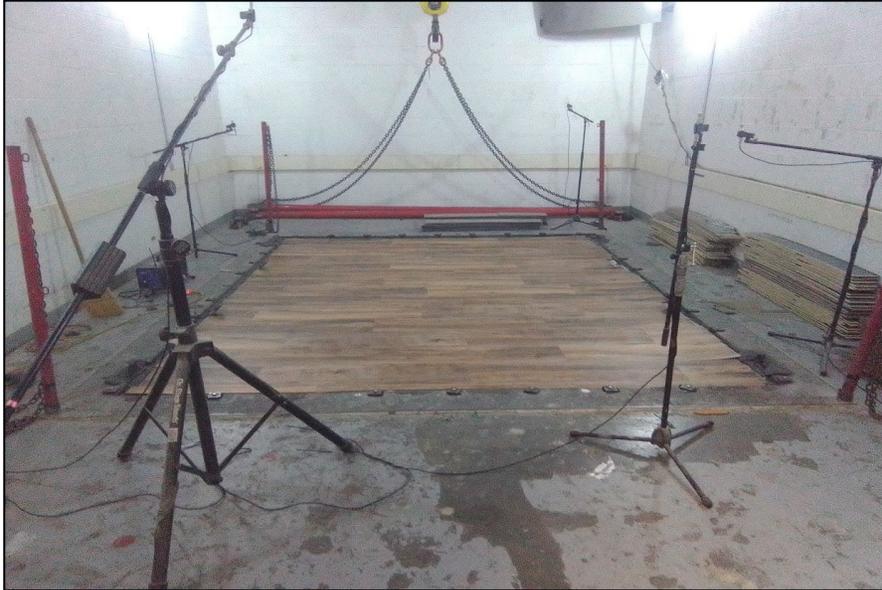
**Photo No. 1**

**Source Room View of Test Specimen Installation**

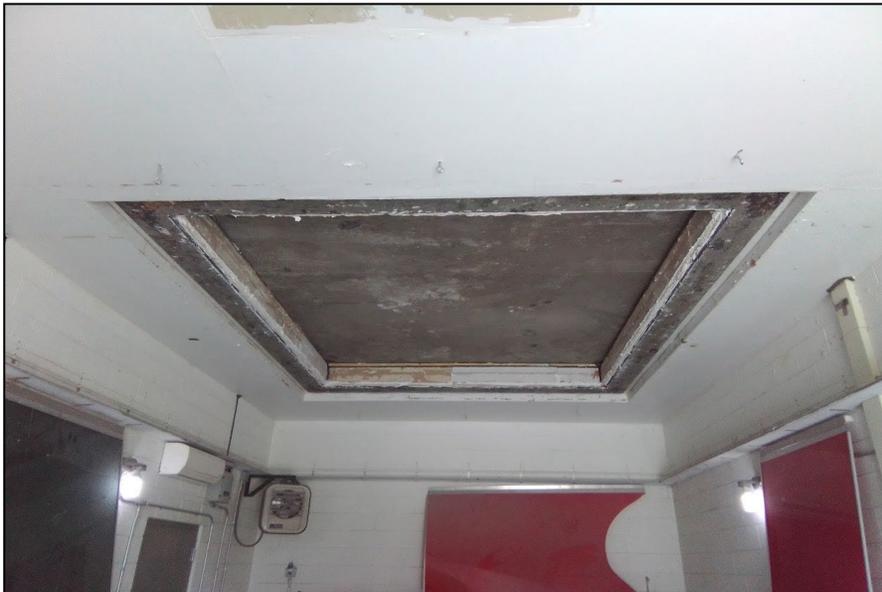
**Photo No. 2**

**Receive Room View of Test Specimen Installation**
