ATTAR TEST REPORT NUMBER: 14/8106.20

WET PENDULUM SLIP RESISTANCE

Prepared for:	Tarkett Australia Pty Ltd					
	16 Anella Avenue					
	CASTLE HILL NSW 2154					
Attention:	Maria Barreto-Tilman					
Test Site:	Test Slip Australia Pty Ltd, Beaumont Hills, NSW.					
Test Date:	12 August 2014					
Test Specimens, Size &	Acczent Ruby sheet vinyl, 300mm x 300mm,					
Quantity:	5 off.					
Sampling & Direction of Testing:	Sampling conducted by client. Test direction not					
	applicable. Refer to Figure 1.					
Test Personnel:	Clark Ahearn					
Preparation:	Washed with water and pH neutral detergent, rinsed					
	with water, then dried.					
Fixed/Unfixed:	Fixed.					
Air Temperature:	20°C					
Test Equipment:	Wessex Skid Resistance Tester (Pendulum) Serial					
	Number SK 1818, Calibrated 29/07/2014.					
Test Standard:	AS 4586: 2013 Slip resistance classification of new					
	pedestrian surface materials – Appendix A.					
Slider Rubber:	Slider 96 Batch No. #53 prepared on P400 & 3µm

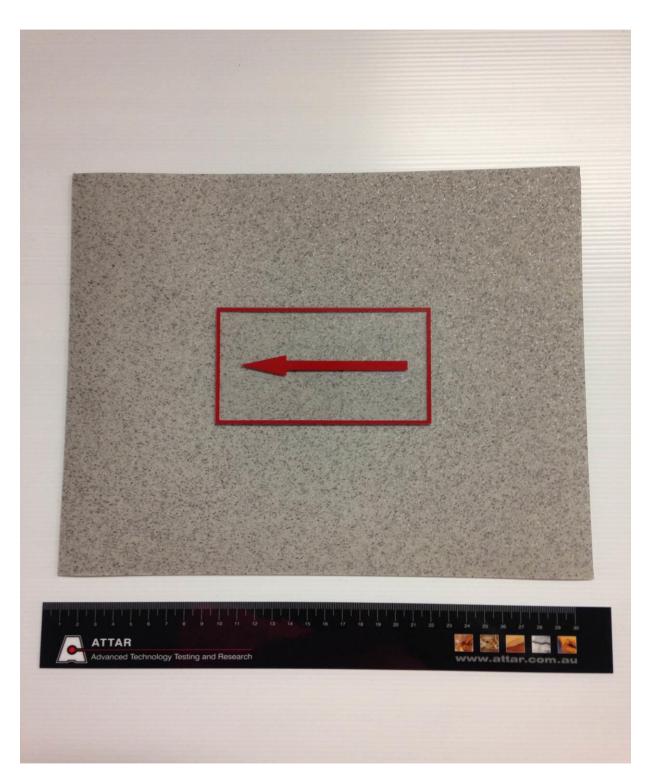
Figure 1: Acczent Ruby – Highlighted area indicates area tested and direction of test.

lapping film.					
Classification Criteria:	Refer to Classification Criteria, attached as Appendix 1.					
	Specimen Number					CDV
British Pendulum Number	1	2	3	4	5	SRV
	33	32	33	33	33	33
Classification:	P2
