## ATTAR TEST REPORT NUMBER: 14/8106.45

## WET PENDULUM SLIP RESISTANCE

Prepared for:	Tarkett Australia Pty Ltd					
	16 Anella Avenue					
	CASTLE HILL NSW 2154					
Attention:	Maria Barreto-Tilman					
Test Site:	Test Slip Australia Pty Ltd, Beaumont Hills, NSW.					
Test Date:	8 September 2014					
Test Specimens, Size &	Primo Safe.T sheet vinyl, 300mm x 300mm,					
Quantity:	5 off supplied.					
Sampling & Direction of Testing:	Sampling conducted by client. Tested parallel with the					
	direction of manufacture. Refer to Figure 1.					
Test Personnel:	Clark Ahearn					
Preparation:	Washed with water and pH neutral detergent, rinsed					
	with water, then dried.					
Fixed/Unfixed:	Fixed.					
Air Temperature:	21°C					
Test Equipment:	Wessex Skid Resistance Tester (Pendulum) Serial					
	Number SK 1818, Calibrated 29/07/2014.					
Test Standard:	AS 4586: 2013 Slip resistance classification of new					
	pedestrian surface materials – Appendix A.					
Slider Rubber:	Slider 96 Batch No. #54 prepared on P400 & 3µm

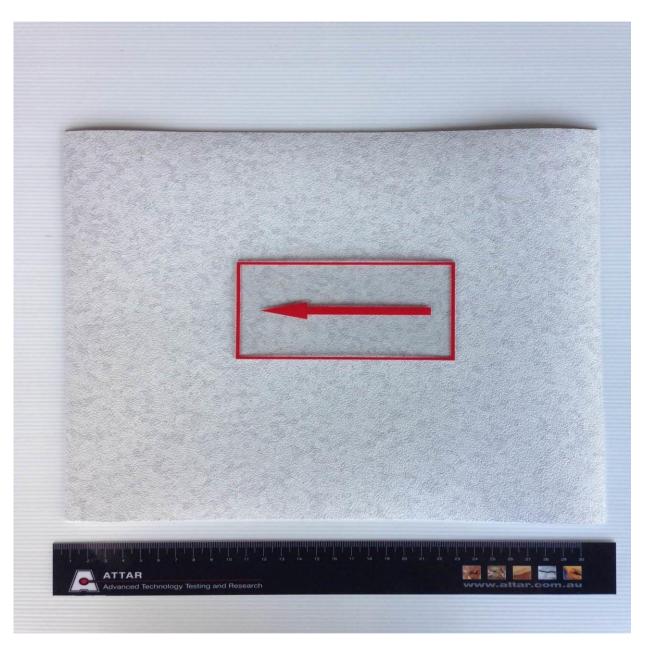
Figure 1: Primo Safe.T – Highlighted area indicates area tested and direction of test.
